# Oil Cooling & Filtration Unit Saves a Critical Asset in a Pharmaceutical Plant

**A standby unit was not an option for Ijssel Predictive Maintenance.**

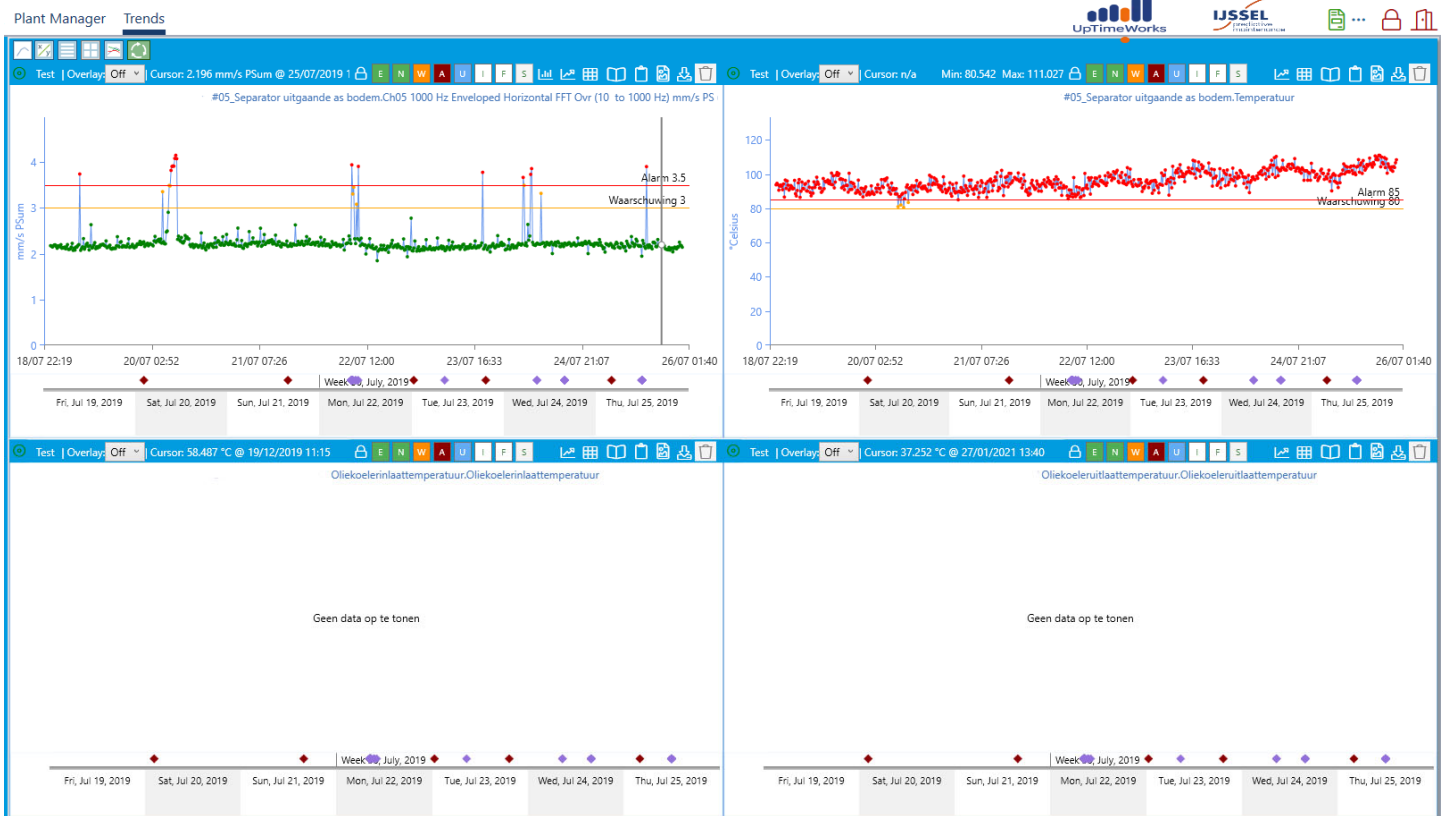
Figure 3: Trend data for the Bottom Output Shaft Separator Module without IJssel's Oil Cooling & Filtration Unit. Clockwise from upper left: Vibration measurements (FFT PEAK; mm/s) shows multiple peaks above alarm values (3-3.5 mm/s); Temperature graph shows a continuous level above alarm values (80-85°C); No data; No data. [Source: UpTimeWorks.com]

For an extended period of time, the plant’s separator had been exhibiting a continuously high oil temperature. This temperature had been wearing down gears through pitting, and it had also affected the fit of the bearings, thus causing looseness and vibration issues on the driving axes.

Simply stated, running the separator with a wet sump gearbox in a continual state of overdrive to meet production schedules is risky because excessive oil temperatures rapidly deteriorate the oil quality. The deteriorated oil then acts as a catalyst in combination with high temperature and high gear-speed to increase wear on moving parts.

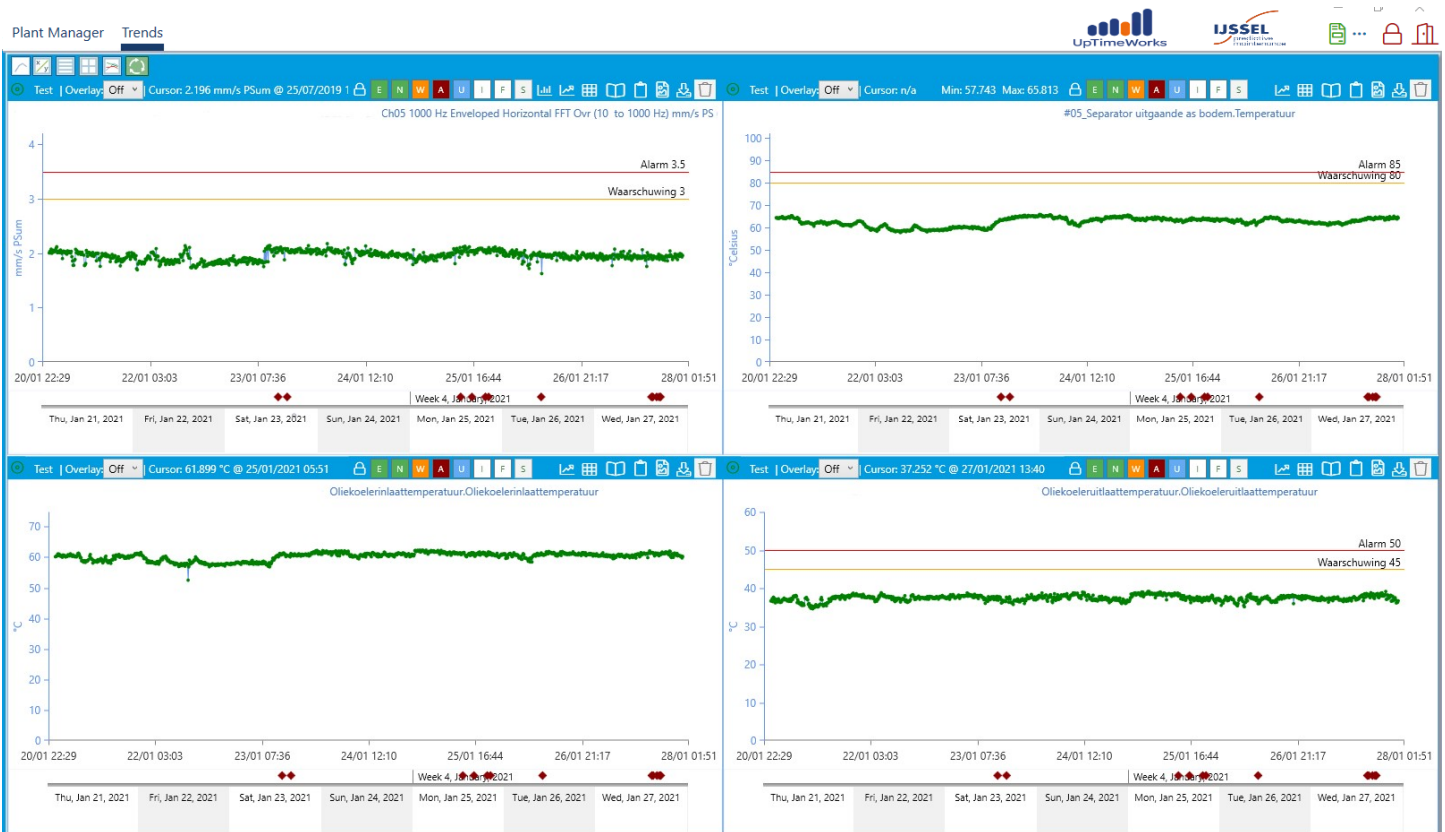
Figure 4: Trend data for the Bottom Output Shaft Separator Module with IJssel's Oil Cooling & Filtration Unit installed. Clockwise from upper left: Vibration measurements (FFT PEAK; mm/s) shows a flared level of peaking below alarm values (3-3.5 mm/s); Temperature graph shows a continuous level below alarm values (80-85°C); Oil Cooling & Filtration Unit outlet temperature graph shows a continuous level below alarm values (45-50°C); Oil Cooling & Filtration Unit inlet temperature. [Source: UpTimeWorks.com]

The results are promising. Cleanliness shows us current levels reaching 19/17/14 (ISO 4406-15) and below, while the gear oil

temperature is controlled from approximately 90°C to a preferred setting of 40 to 60°C.

Additionally, reduced from its previous twice-weekly oil change schedule, the separator proceeded to run without any problems at least six months on the same oil, saving a considerable amount of loss on turnover. Today, the separator is also continuously monitored with vibration sensors by IJssel Predictive Maintenance with our own UpTimeWorks condition monitoring system. Vibration is significantly reduced with the cleaner and cooler oil while temperature remains monitored online, too.
